About Bongate Weir

What's the problem?

Conclusion

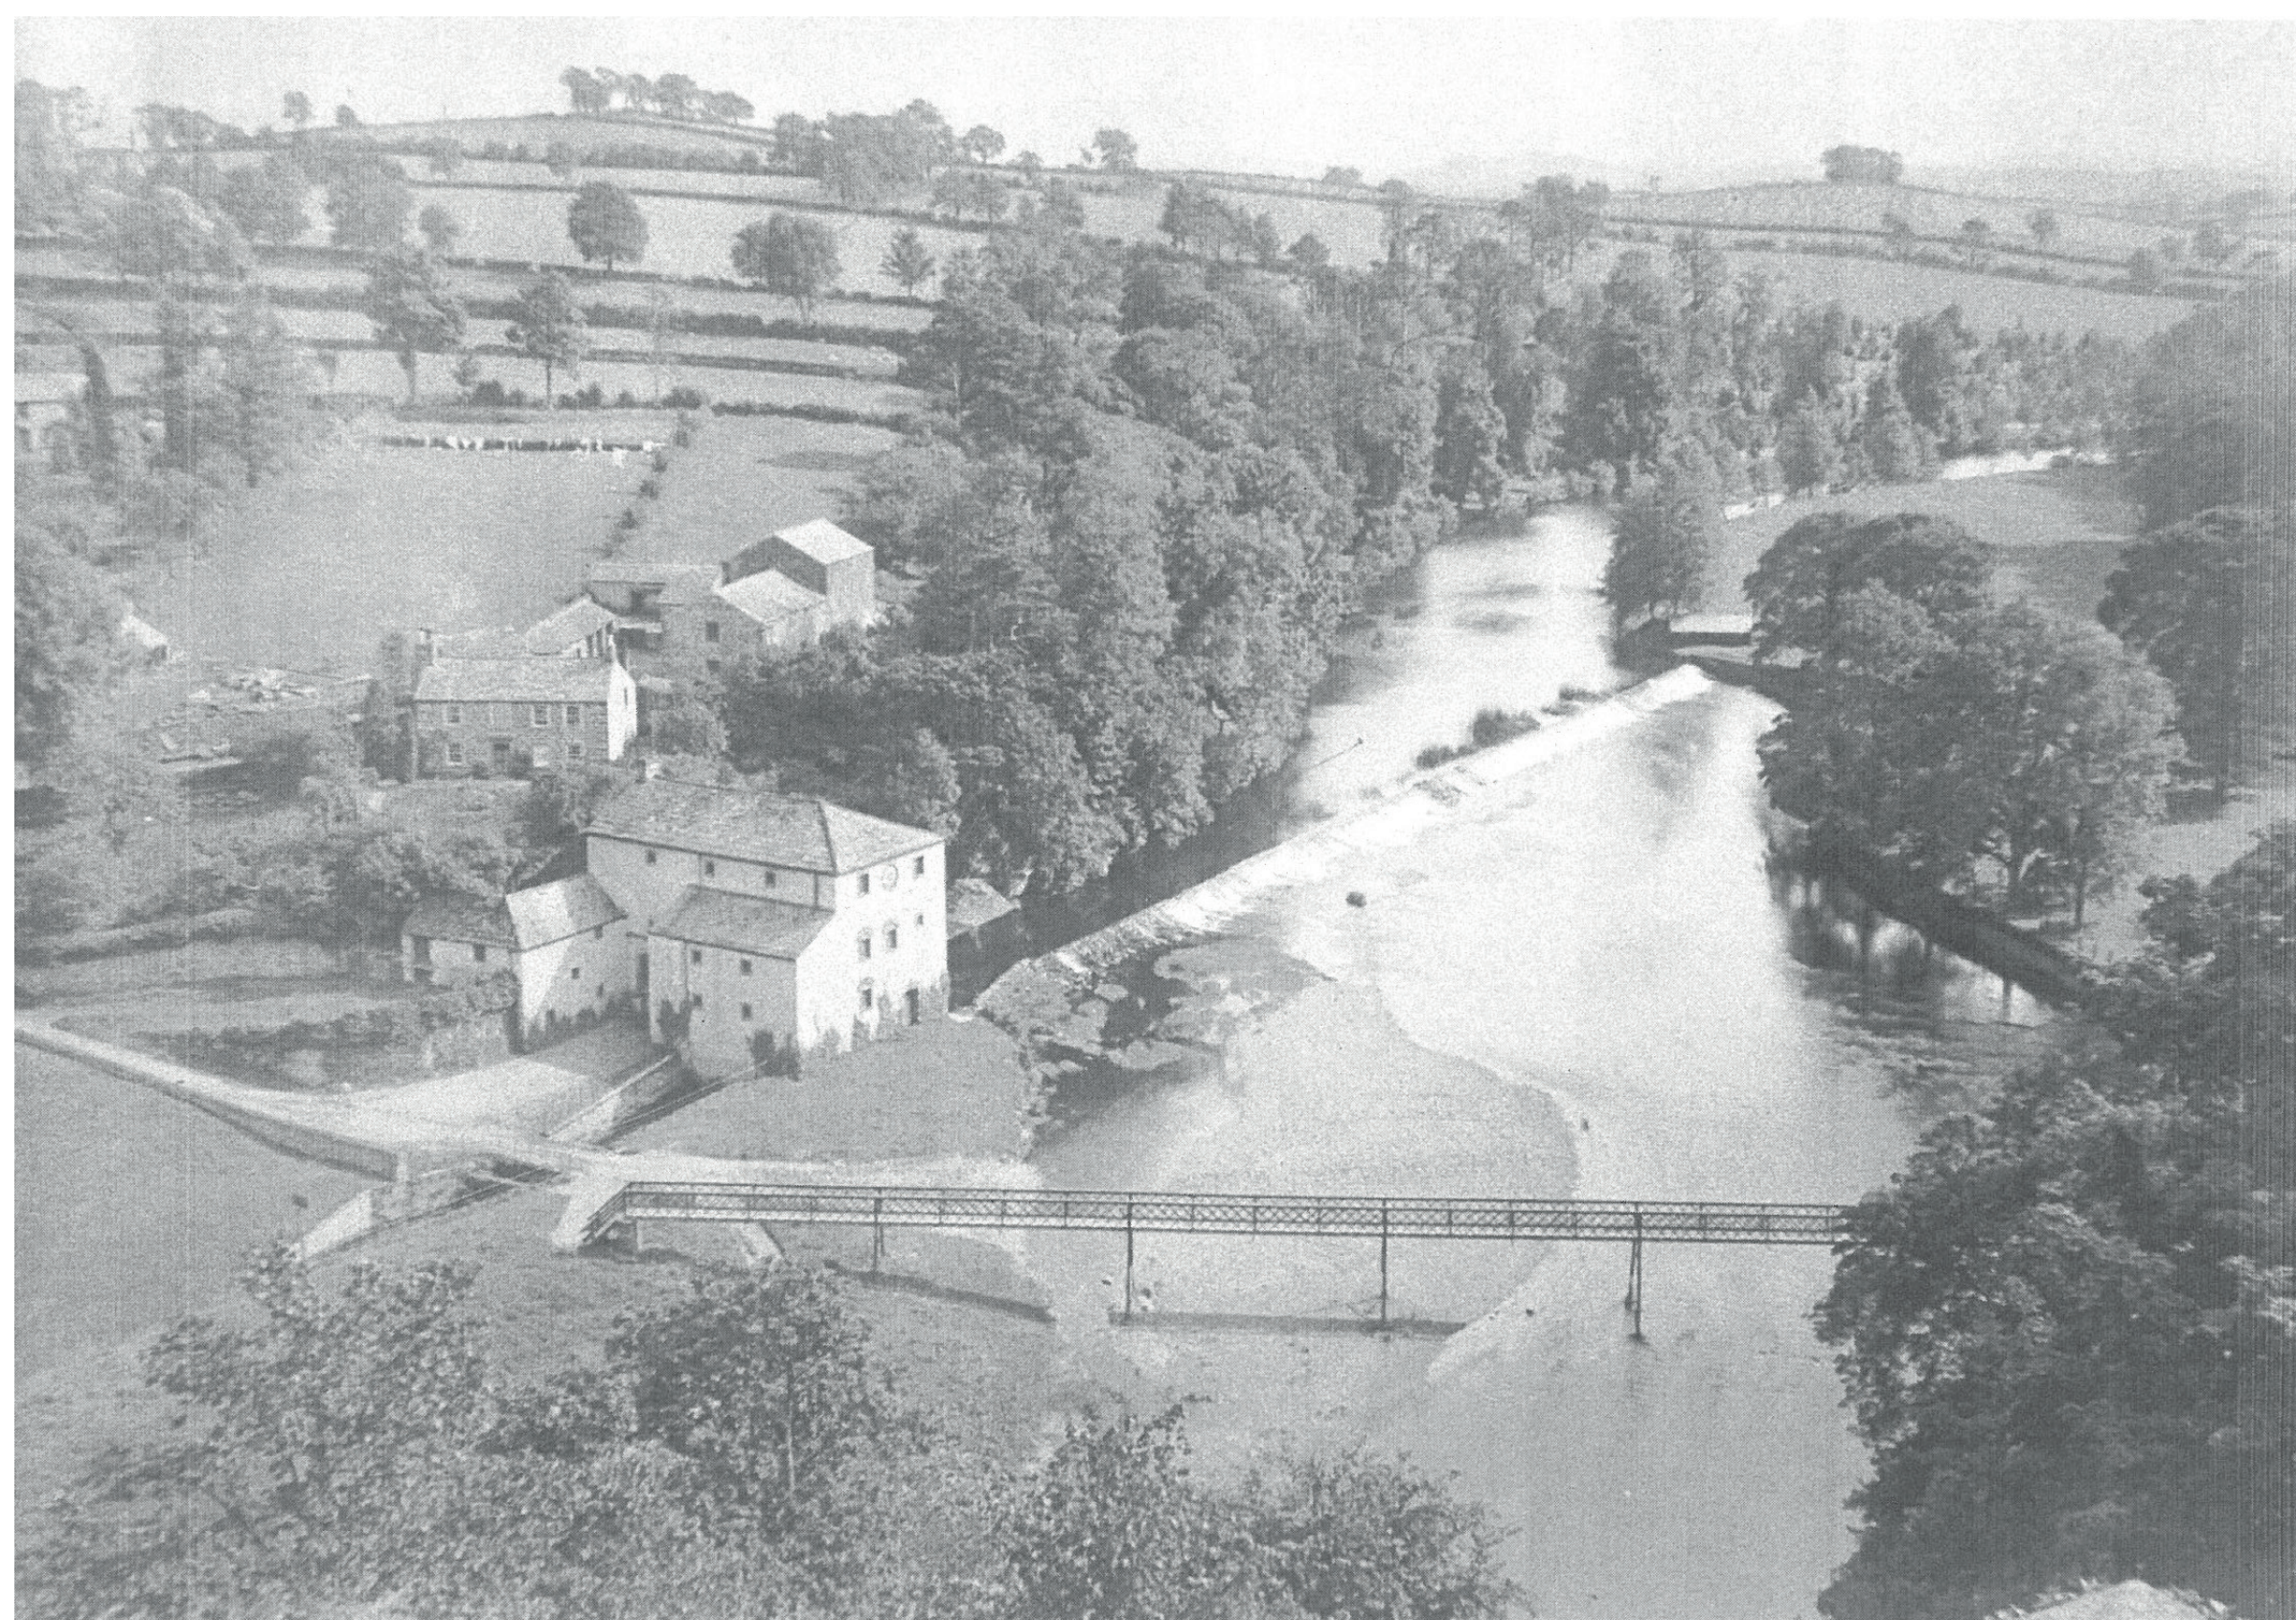
Bongate weir mill race from Appleby Castle

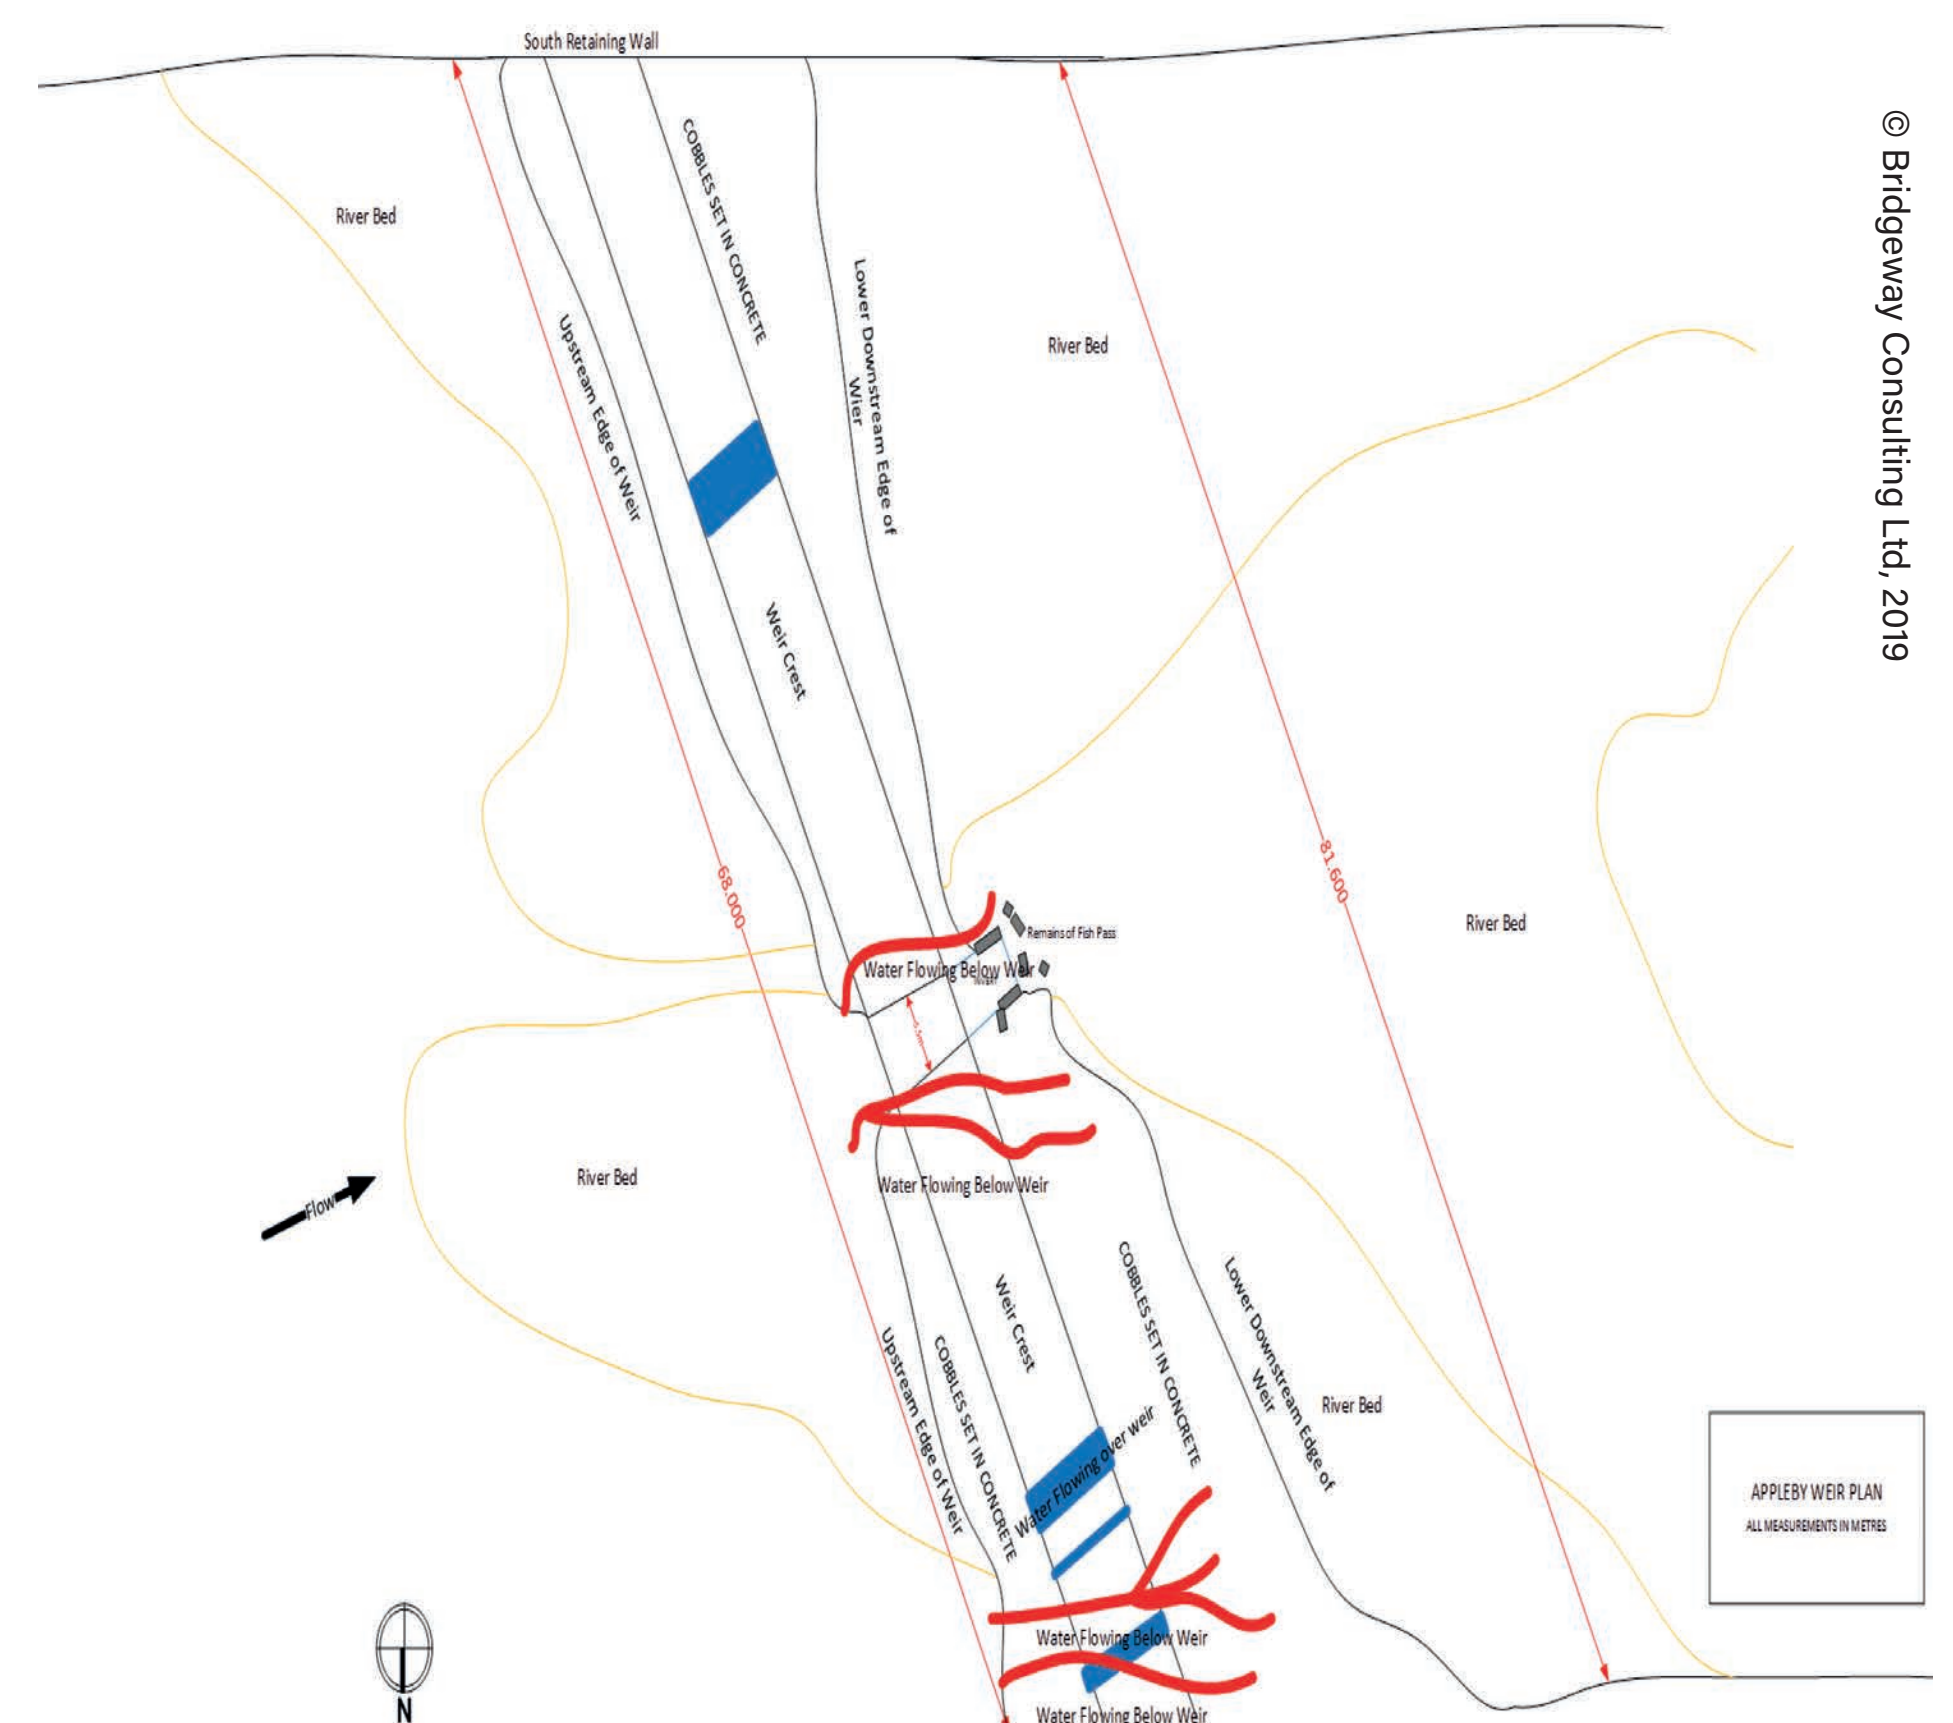
Locations of major damage identified in the underwater examination report (Bridgeway Consulting Ltd, 2019)

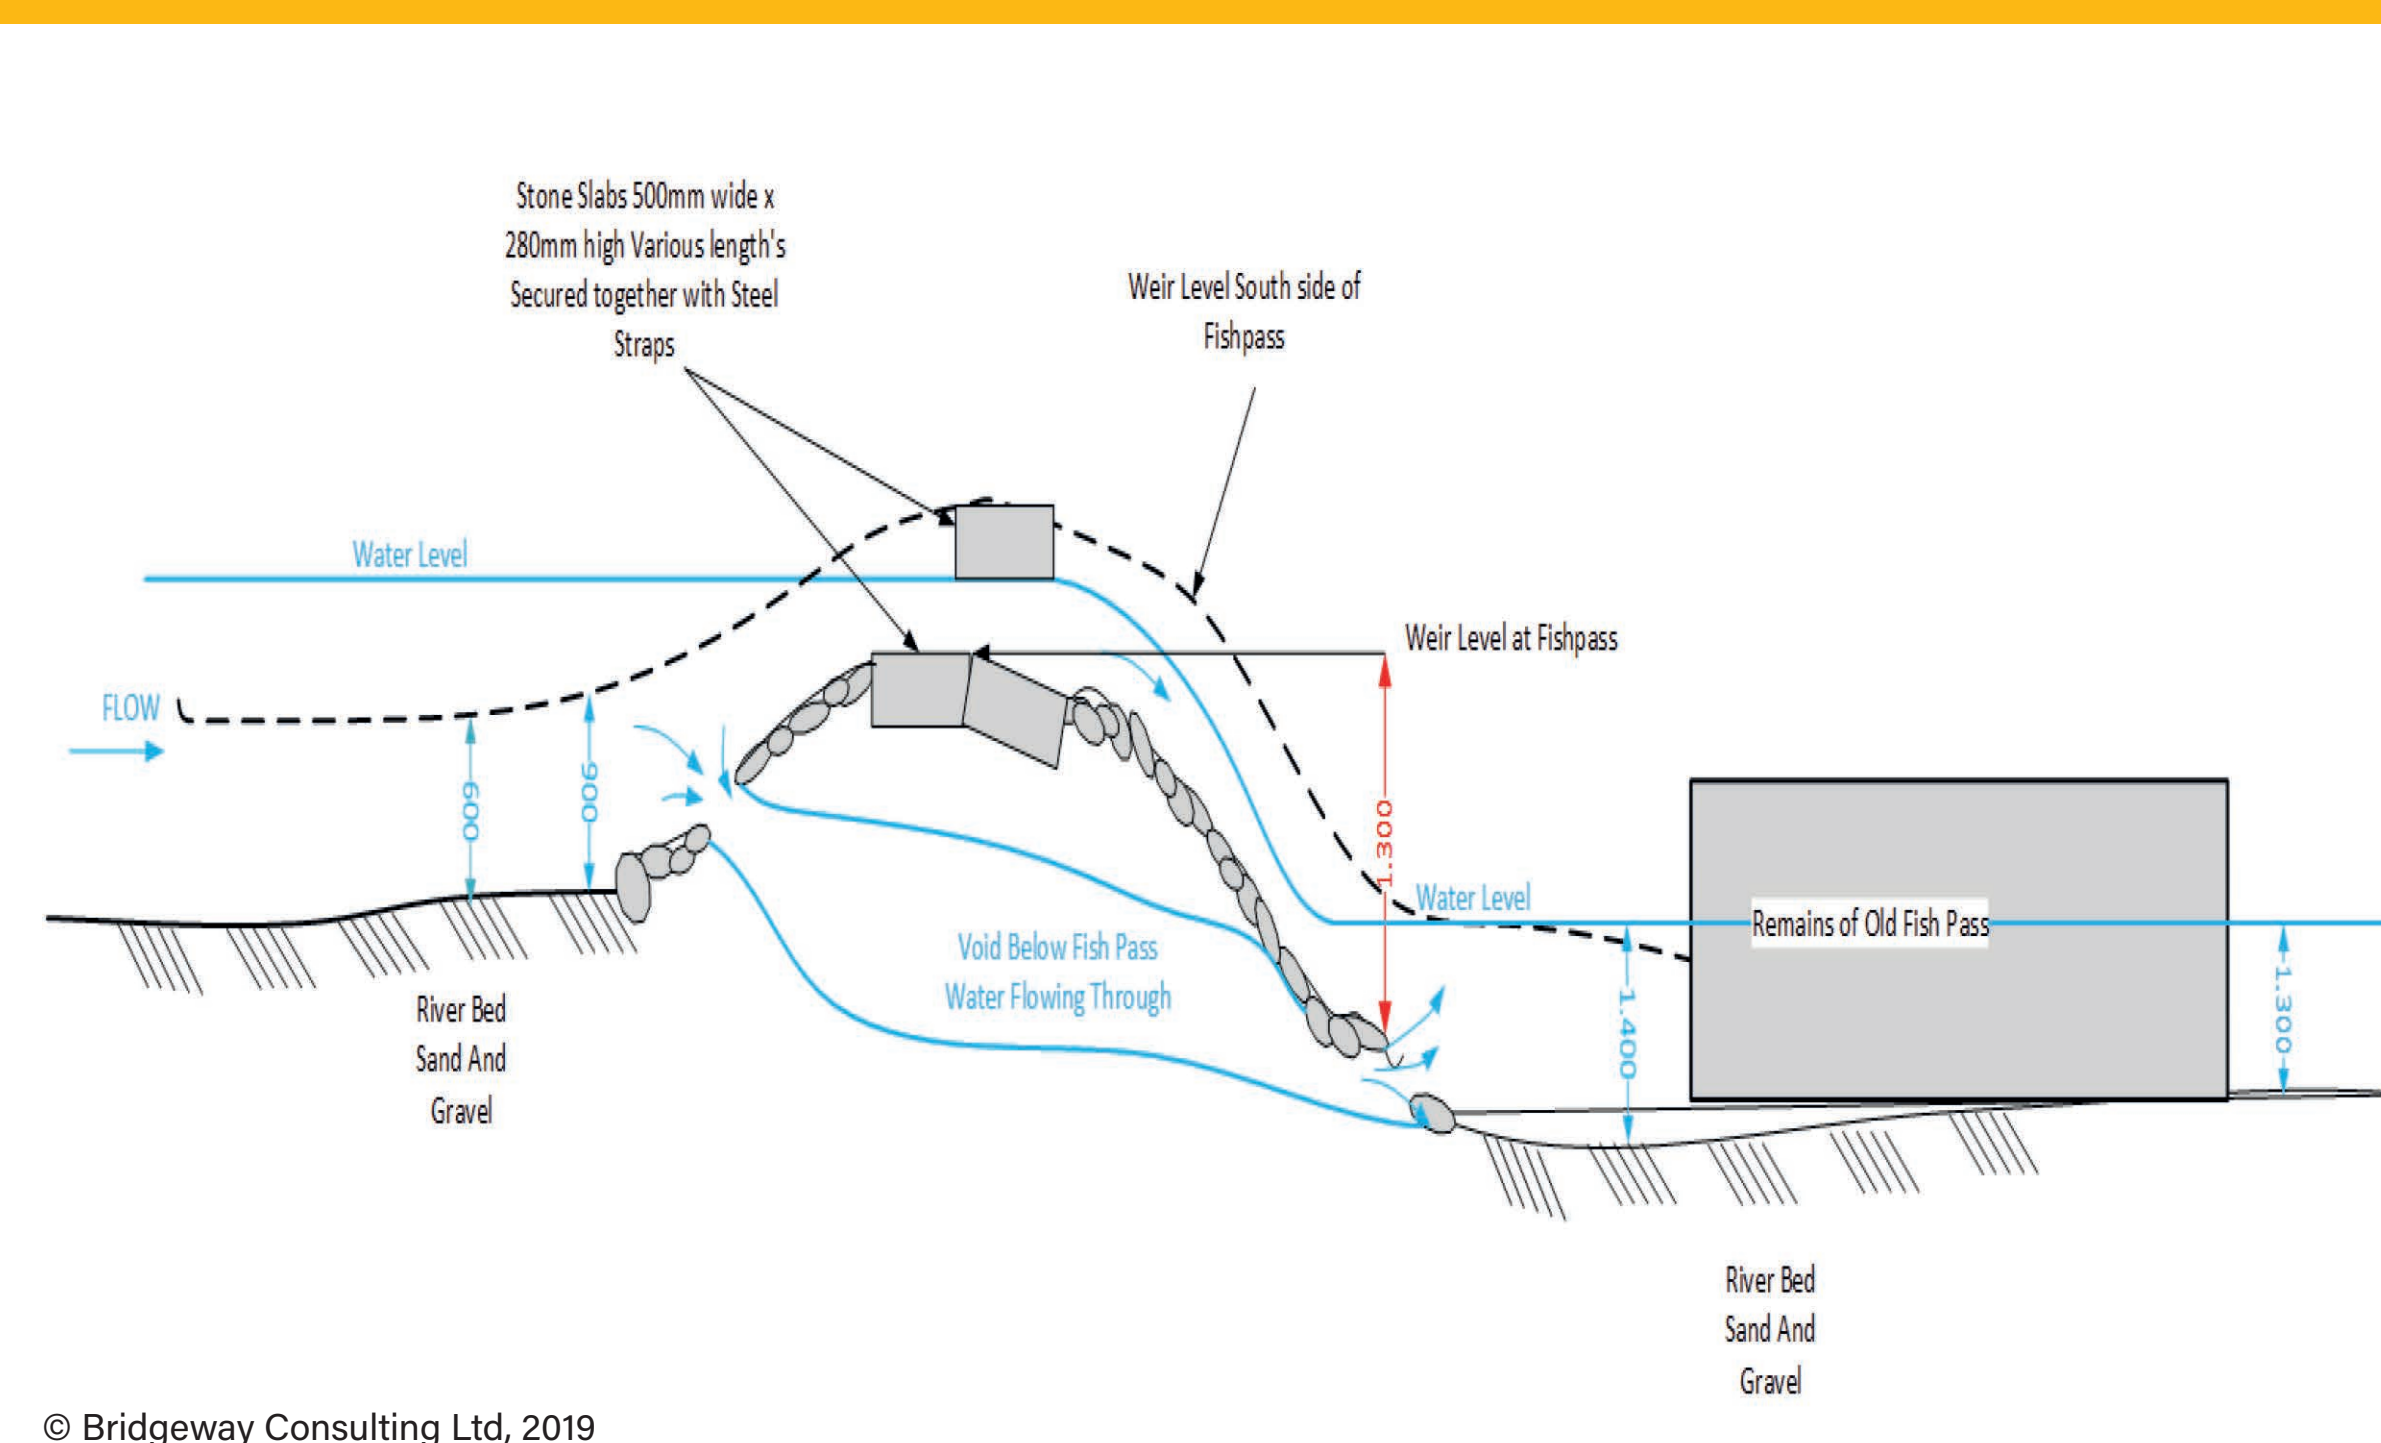
Cross-section through Bongate weir fish pass (42m from the riverbank)

- The work undertaken in 2000 to repair the original breach in the centre and lower the weir to aid fish passage is now broken and undercut.
- Much of the concrete is now scattered in the river below the weir.
- Water is being channelled around the remains of the structure and through it.
- There are two large holes at the river bed level (1.4m deep by 10x60cm) and (1m deep by 20x50 cm) with fast flowing water being forced through them.

“ The holes within the weir structure are causing the water flow to be unnaturally drawn through the weir and not over it, causing differential pressure to be created [this means that the water is flowing through the holes much faster than over the top].

This is potentially dangerous for anyone who accidentally fell into the water. They could get stuck within the holes and it would be difficult to extract them, due to the differential pressure and downward drag of the water flow.
