Examination of the study weir indicated utilitarian sandstone construction. The weir possibly dating from the mid-1860s to 1899 displayed little architectural merit and there were no embellishments or decoration.

Cumbria County Council Historic Environment Service (Development Control) was consulted by Eden Rivers Trust regarding the demolition of a weir in order to improve the flow of the River Eamont and prevent localised flooding (figure 1).

The development proposal covered by planning application 16/0459 will remove an extant weir and as a result, a building survey has been requested by the curatorial authority requiring a programme of archaeological building recording to be undertaken prior to any demolition taking place.

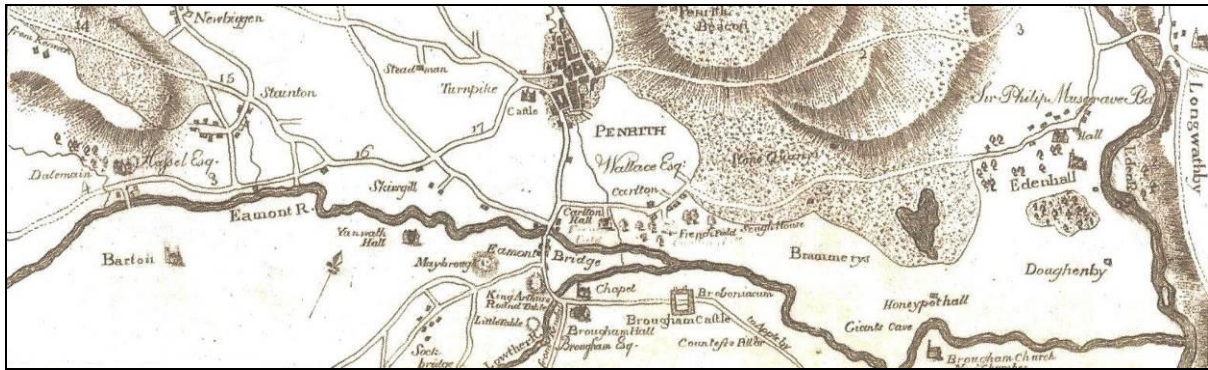
Figure 3. Hutchinson's map of the River Eamont published in 1794

Hutchinson's map published in 1794 illustrates Thacka Beck discharging waste water into the River Eamont and also the River Lowther from Penrith town centre (figure 3). The distinctive loop that was extant by 1860 on the first edition Ordnance Survey map (figure 4) was not present on the earlier map (Hutchinson 1794, 312-313). The tithe map for the township of Carleton produced *circa* 1840 was not available for inspection at Cumbria Record Office.

Such variation does suggest that the river system had been remodelled in the early 19th century introducing a bend to the north and removing the earlier straighter course evident in the 18th century.

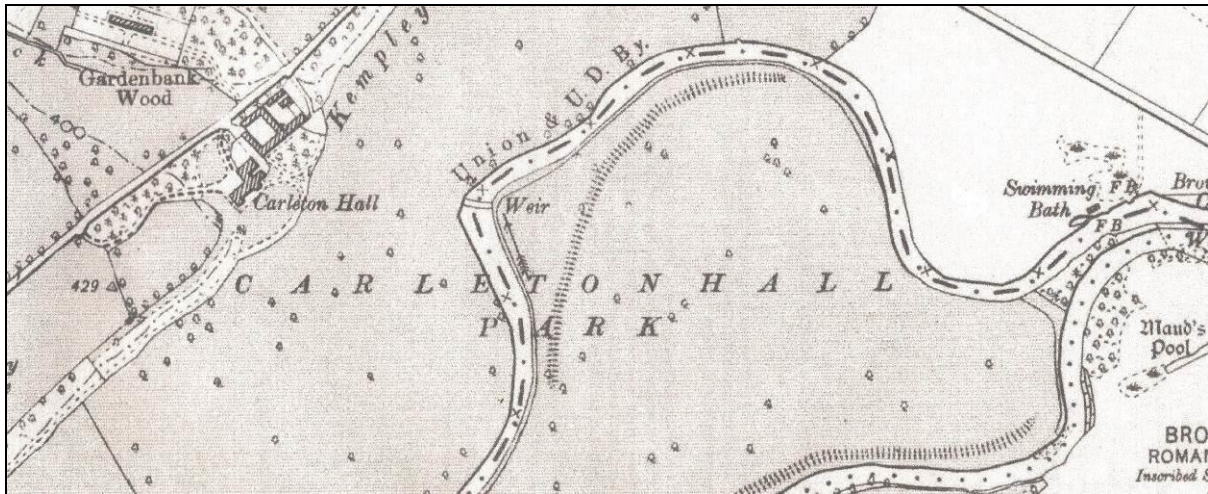
Figure 5. Ordnance Survey map of 1899

Evidence for this action was not clear although an oxbow seen in the adjacent southern field by the author may conform to an arcing feature known as Westmorland Holme Dyke (figure 5). Illustrated

no earlier than the 1899 Ordnance Survey, it is believed to belong to a later system of river management (FAS 2016, 11).

The wider park is shown as an open expanse with little variation since the mid-19th century. The weir first appears on the 1899 Ordnance Survey map probably contemporary with the Westmorland Holme Dykes also illustrated. These heritage assets are currently in a poor condition.

Thacka Beck does not appear on Ordnance Survey mapping as discharging into the River Eamont terminating at Gardenbank Wood (figure 5). Presumably, the course from Gardenbank Wood to the Eamont had become a culvert by the mid-19th century, discharging beside the weir as an open cut.

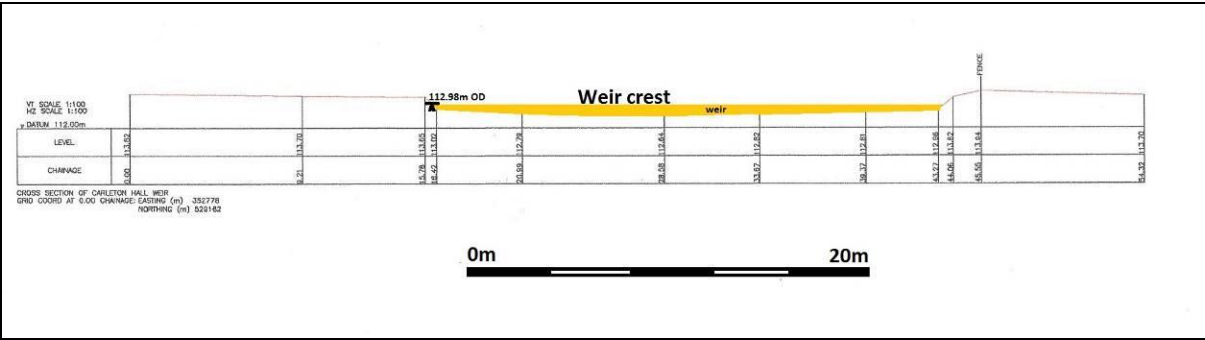
Figure 6. Elevation across weir

The weir measured 24.85m in length and 3.60m in width and was formed from undressed, rough-hewn red sandstone blocks arranged in a stepped formation two courses high on the south side that was approximately 1.00m in height (figures 6 and 7).

The sandstone blocks were 0.50m in height and left unbonded, producing a concordant surface formed from approximately seven rows of stone.

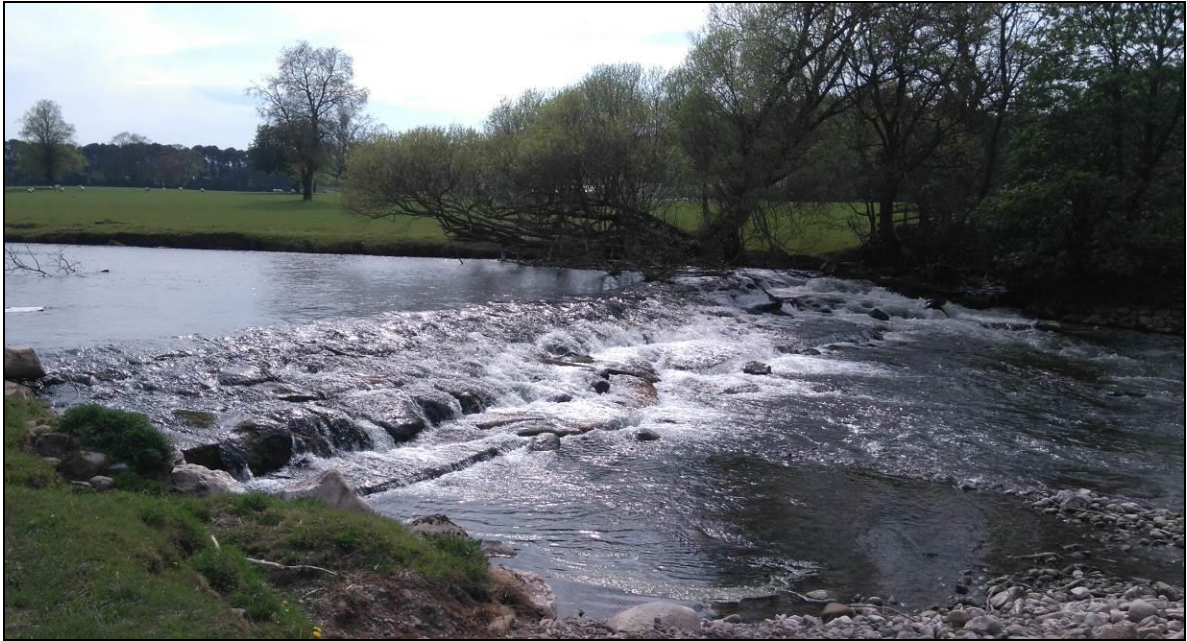
Figure 7. The weir at low water level

On the southern side, the sandstone blocks were neatly inter-locking but mid-stream this quality diminished, developing into a series of sandstone blocks that were arranged with less deliberation (figure 7). This suggests that construction had emanated from the southern side with contractors utilising the sandstone platform to encroach into the river.

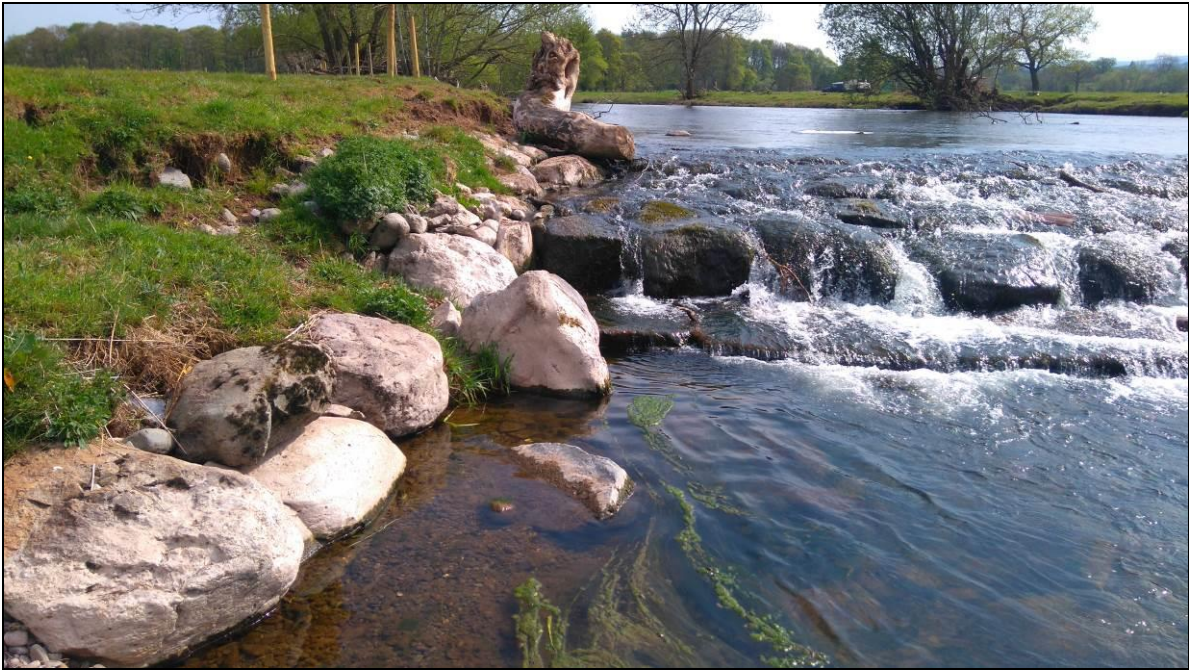
Figure 8. Sandstone blocks forming the weir on the south side with stone revetment

The river margins on both sides of the river had been formalised by coarse rubble walls forming revetments probably contemporary with the introduction of the weir (figure 8).

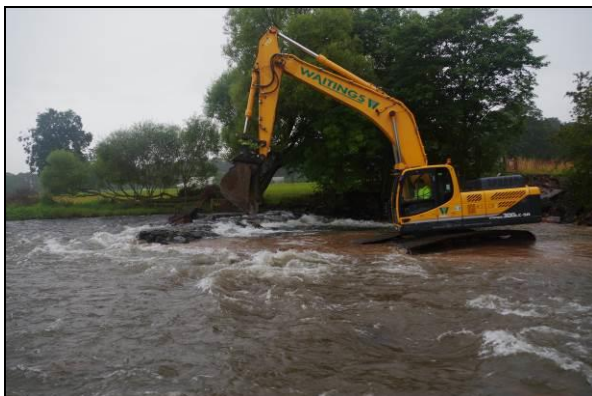
Figure 9. Removal of the weir

Proceeding from the south bank, the removal of the stone weir was undertaken by a 30 tonne excavating machine sitting within the river (figure 9). Each red sandstone blocks was easily lifted confirming that these stones were unbonded and rough-hewn (figure 10). The removed stone was employed to build a rock shield on the northern side of the river in order to protect the bank from erosion (figure 13).

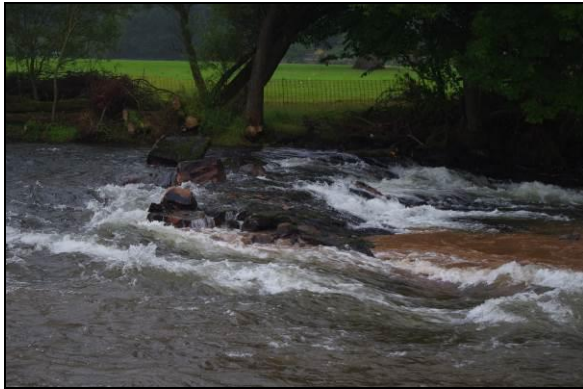
Figure 11. Part of the weir during removal

The removal of the stone weir on the south side produced a deeper channel that exposed the weir in section, revealing a slightly bevelled stone surface (figure 11). It was unknown whether there was any stone core to the weir but this was probably unlikely.

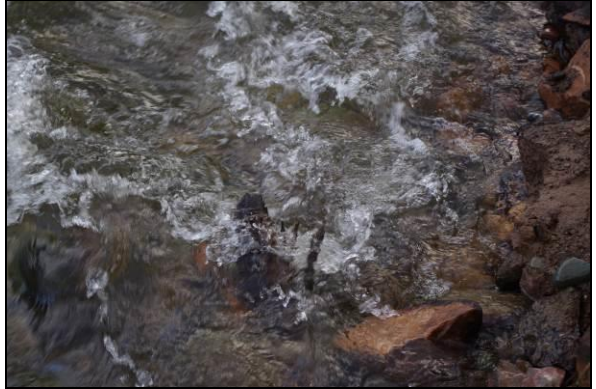
Figure 12. Timber pile

A wooden pile was observed on the southern side of the river (figure 12). It is not known whether this was part of a tie relating to a late 19th century construction programme perhaps part of a coffer dam or whether an earlier predecessor to the weir was identified.

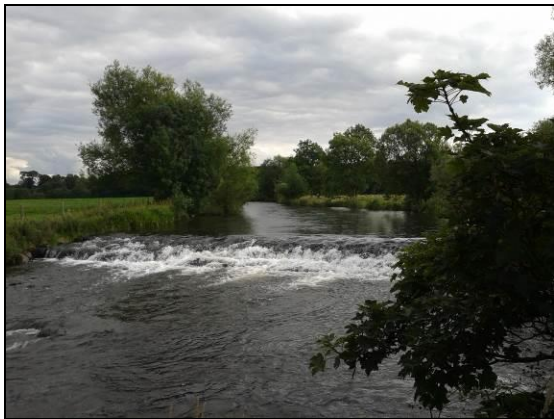
Figure 13. River Eamont with weir

This demolition action removed a fall (figure 13) leaving a relatively even river bed with water turbulence greatly reduced (figure 14).

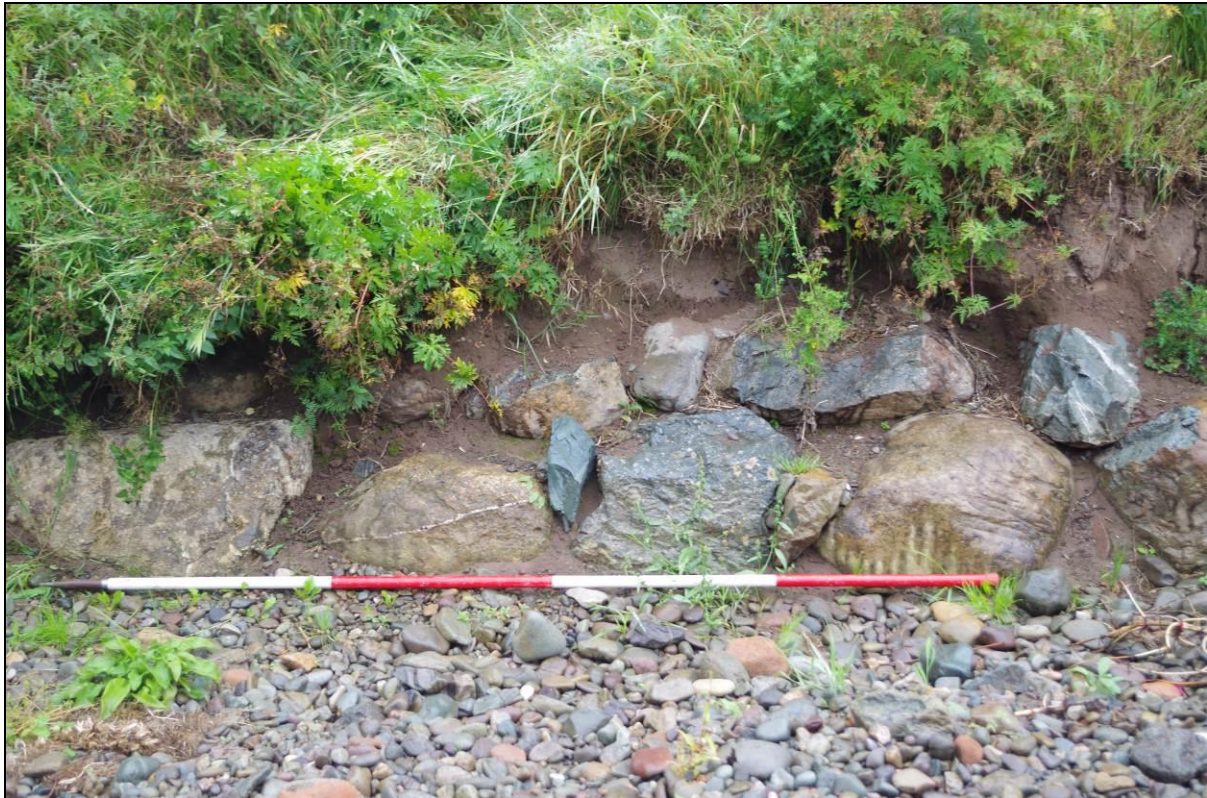
Figure 15. Stone revetment

The stone revetment that cut into brown alluvial sand (figure 15) and the weir appear to be contemporary. There remains a good case that the weir and revetment were introduced simultaneously, whilst the bed of the river was relatively dry either through the introduction of a coffer dam or as a new engineering enterprise.
