About Bongate Weir

What's the problem?

Conclusion

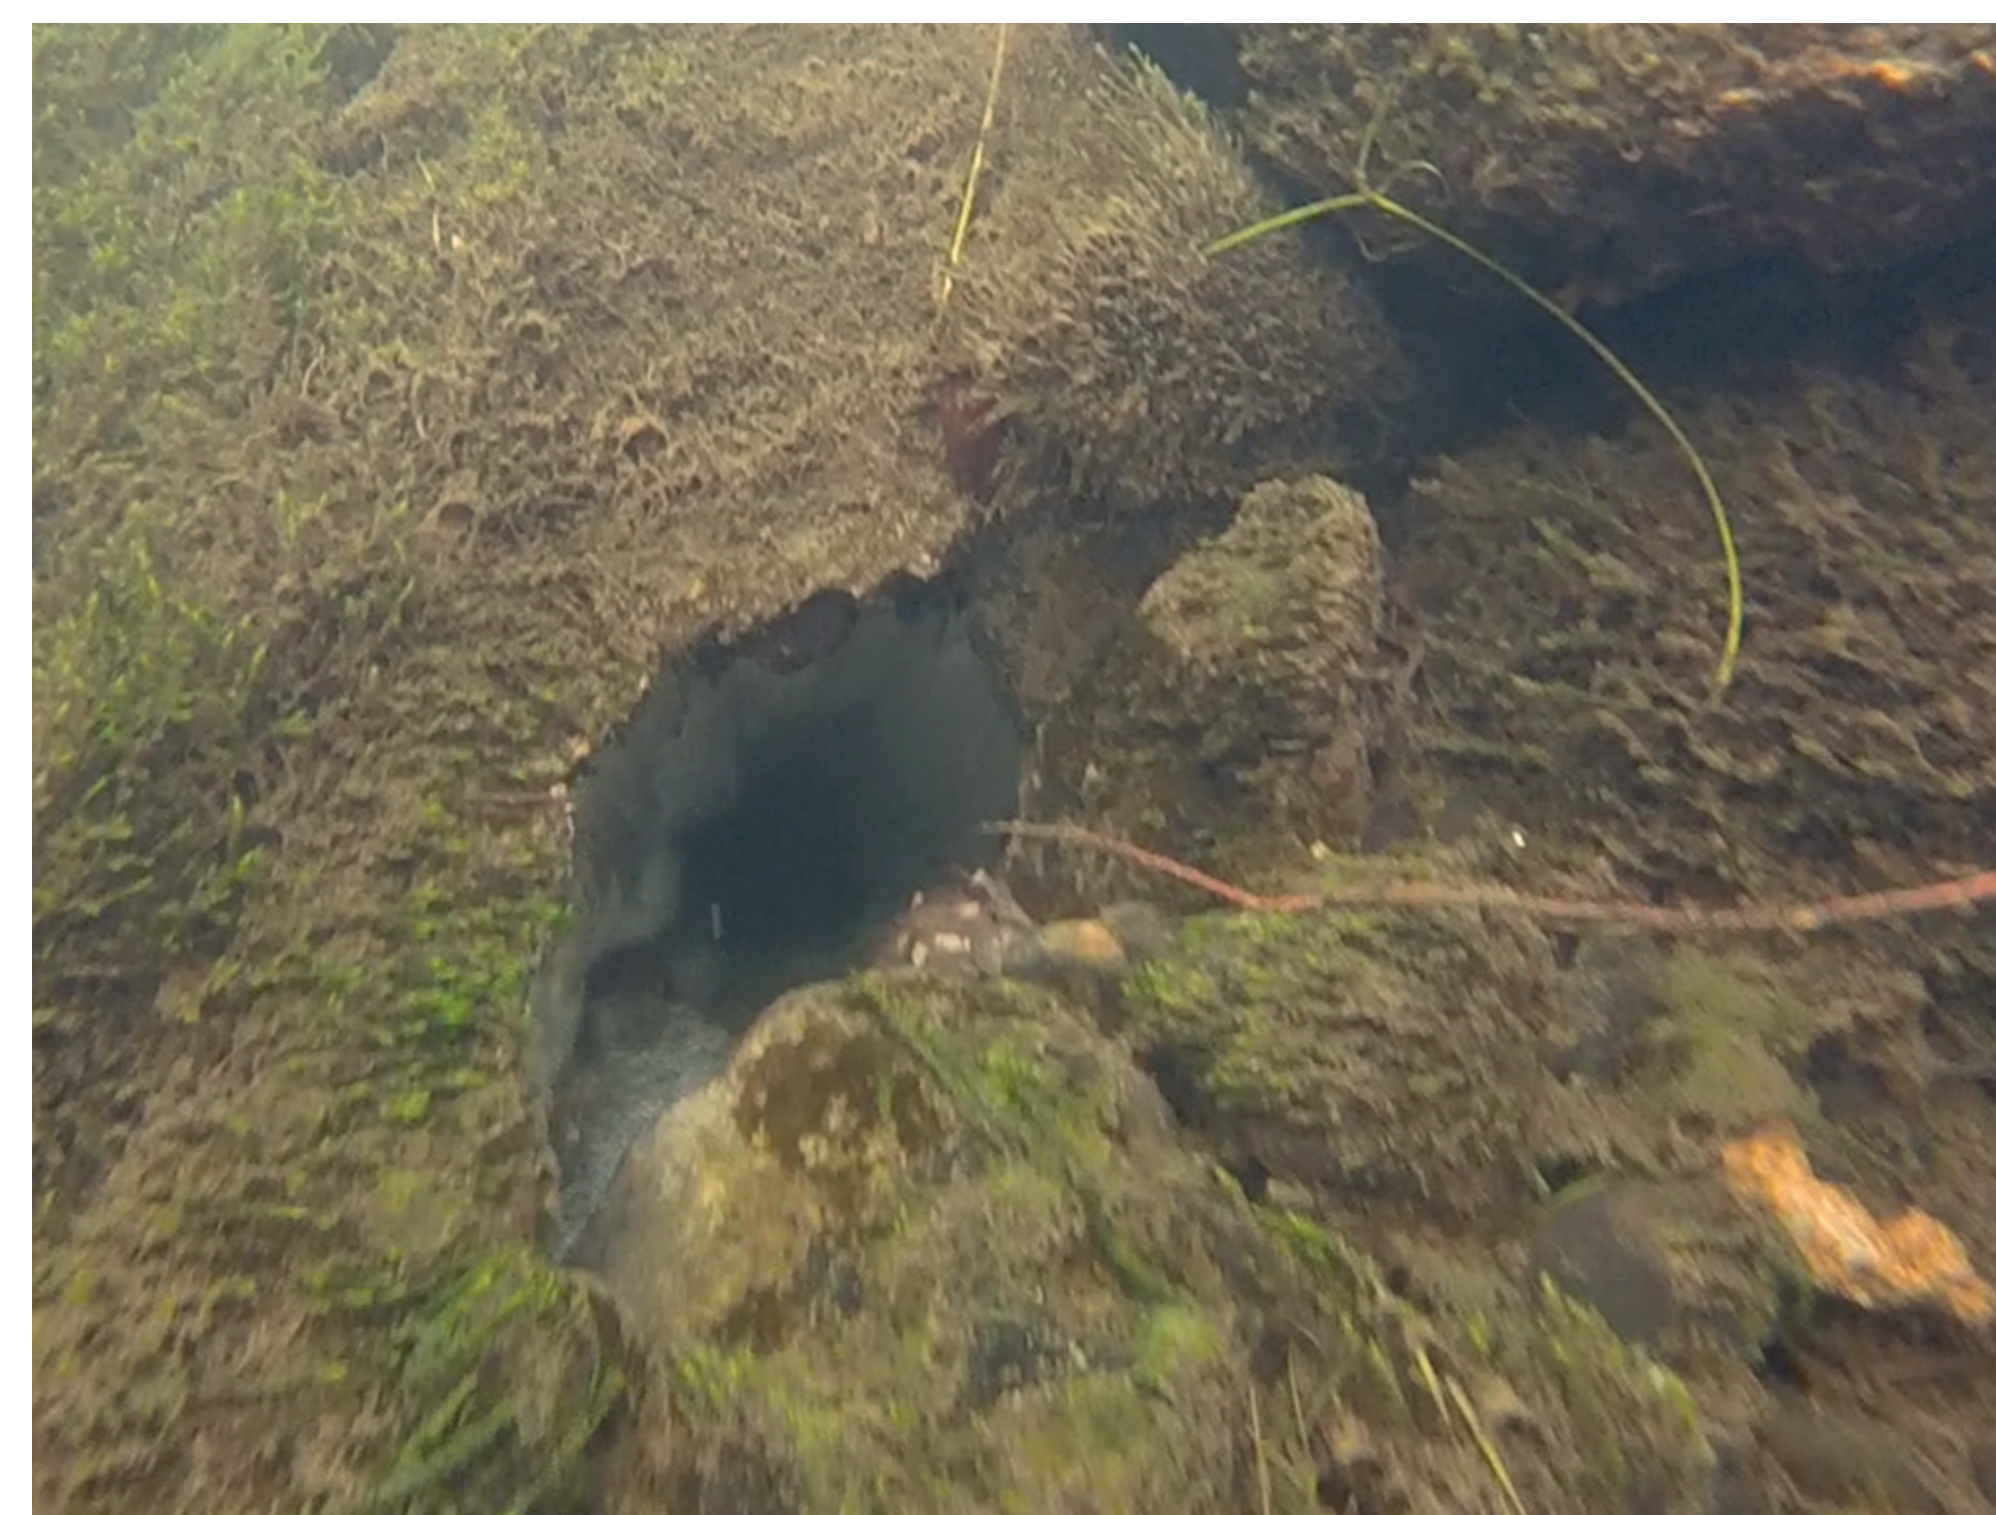
Locations of major damage identified in the underwater examination report (Bridgeway Consulting Ltd, 2019)

- The work undertaken in 2000 to repair the original breach in the centre and lower the weir to aid fish passage is now broken and undercut.
- Much of the concrete is now scattered in the river below the weir.
- Water is being channelled around the remains of the structure and through it.
- There are two large holes at the river bed level (1.4m deep by 10x60cm) and (1m deep by 20x50 cm) with fast flowing water being forced through them.

This is potentially dangerous for anyone who accidentally fell into the water. They could get stuck within the holes and it would be difficult to extract them, due to the differential pressure and downward drag of the water flow.

We [Bridgeway Consulting] have been made aware that there have been previous incidents of this nature in the recent past and if remedial action or removal of the weir does not happen soon, then these types of incidents could increase as the weir structure deteriorates.
